Multivehicle Crash Near Mt. Pleasant Township, Pennsylvania

Crash Summary

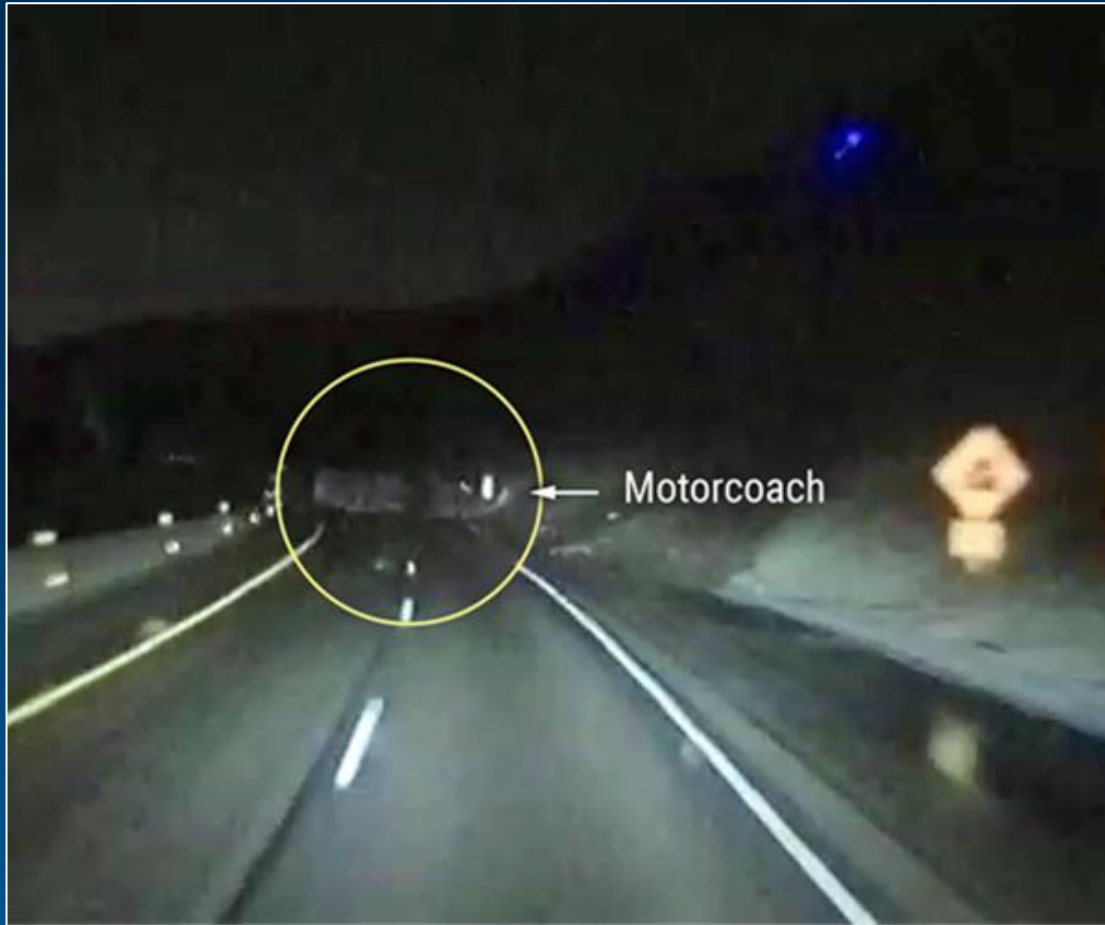
Overtaken Motorcoach

- Initial position of rest was blocking both travel lanes and shoulders
- Entered curve at 77 mph
- Light braking upon entering curve decreased speed to 70 mph
- After brakes released vehicle speed changes not associated with braking or throttle occurred
- Speed changes consistent with vehicle yawing from excessive steering inputs
- Sufficient roadway traction existed for normal travel

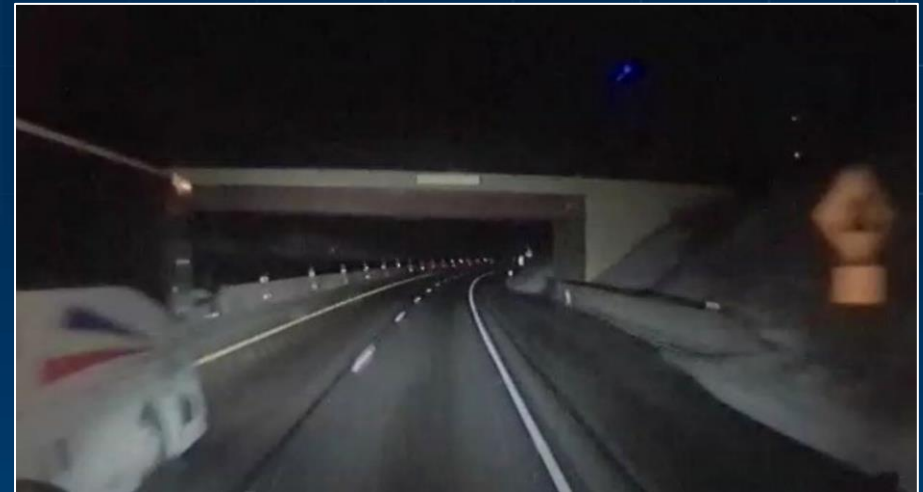
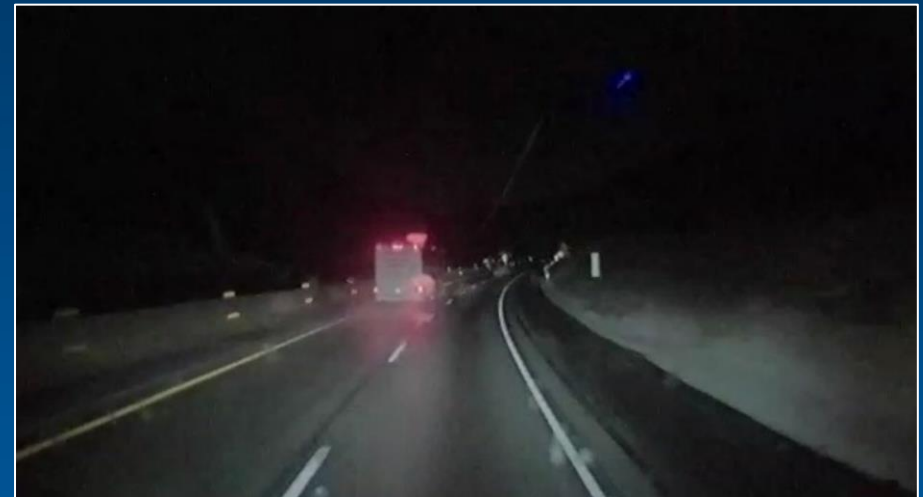
Onboard Video Event Recorders

- FedEx truck video system provided key information:
 - Motorcoach speed and lane position when passing
 - Position and visibility of overturned motorcoach on roadway
 - FedEx driver reacted quickly to hazard
 - FedEx truck speed and crash severity

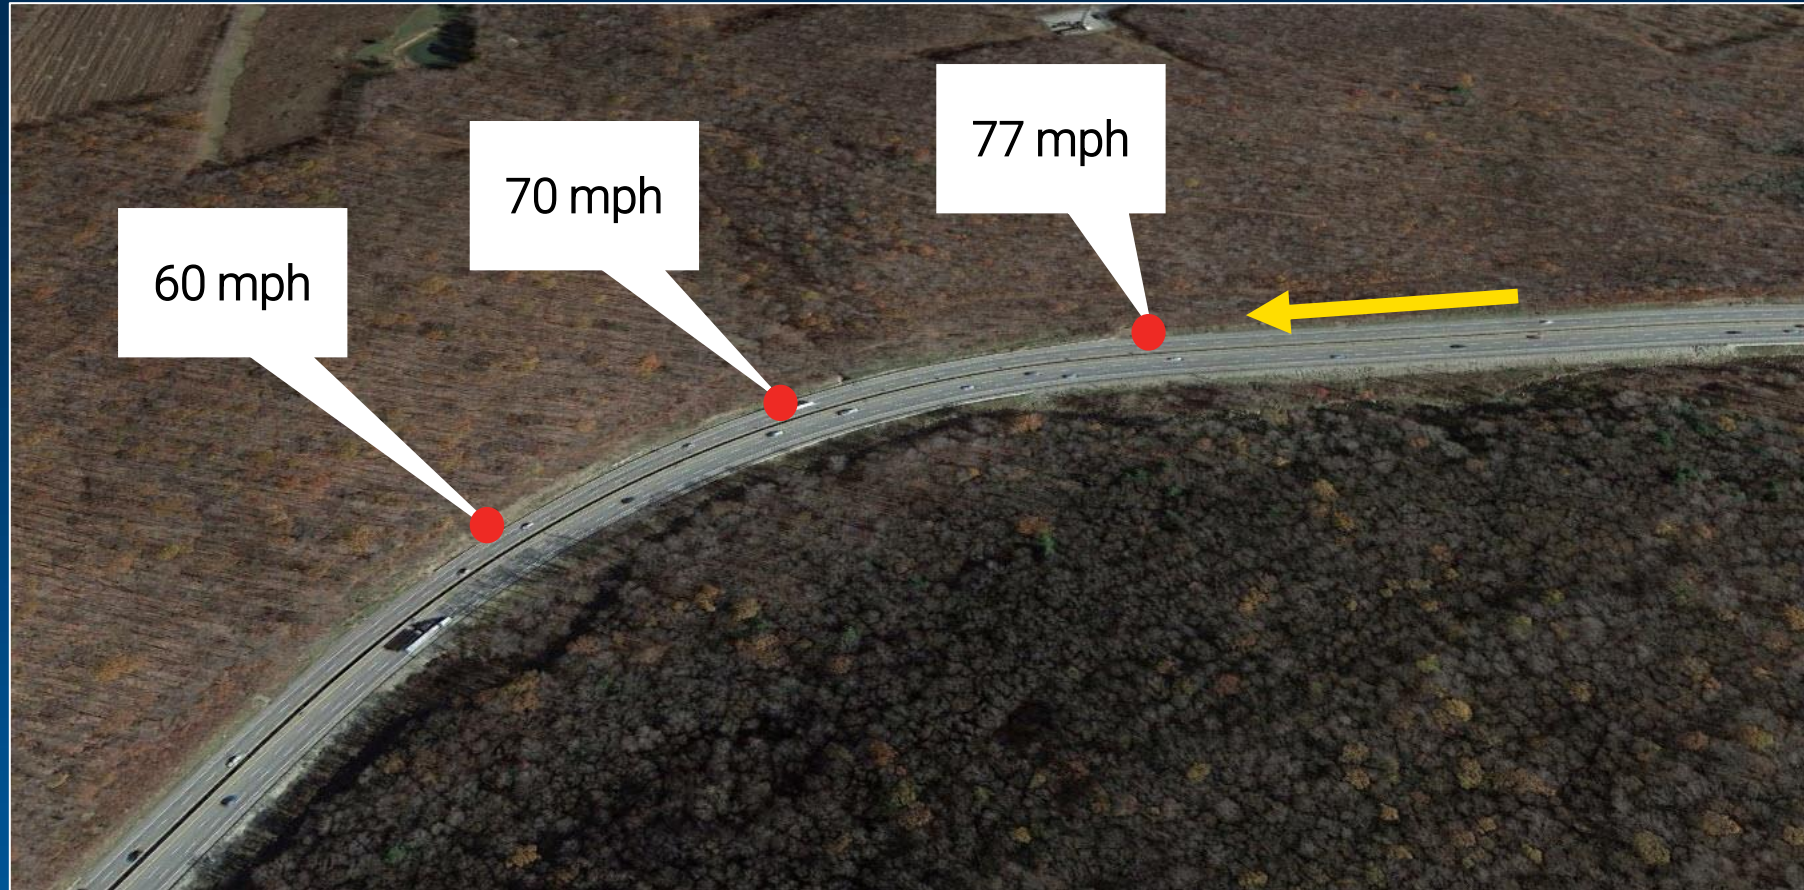
Motorcoach Driver

- Traveling at excessive speed on wet roadway in descending curve
- Excessive speed, roadway conditions contributed to loss of control
- Driver likely made excessive steering inputs
- Likely engine brake contributed to loss of traction

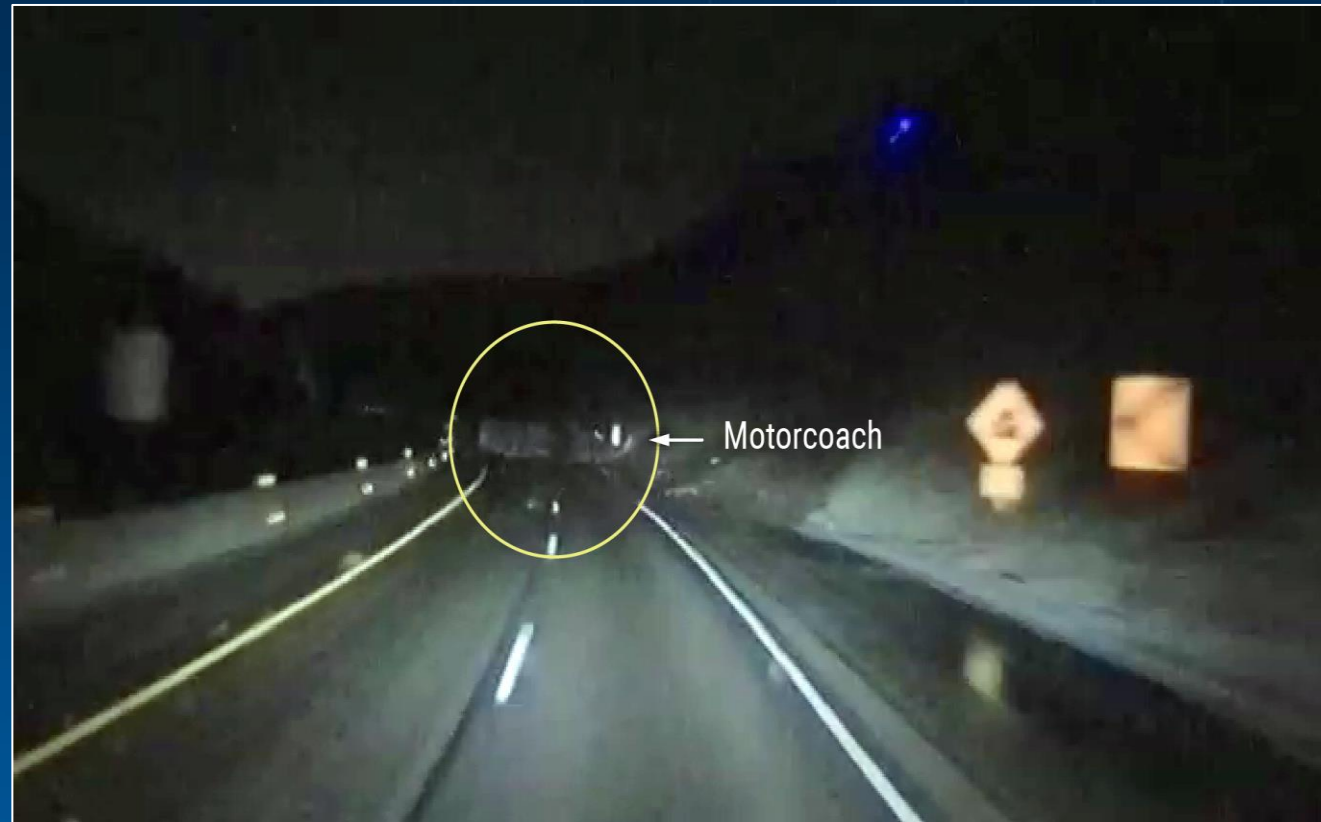
FedEx Driver Response

- FedEx truck entered curve at 53 mph
- Driver steered to left, applied brake
- Driver reacted within 0.3 seconds
- FedEx truck slowed to 21 mph

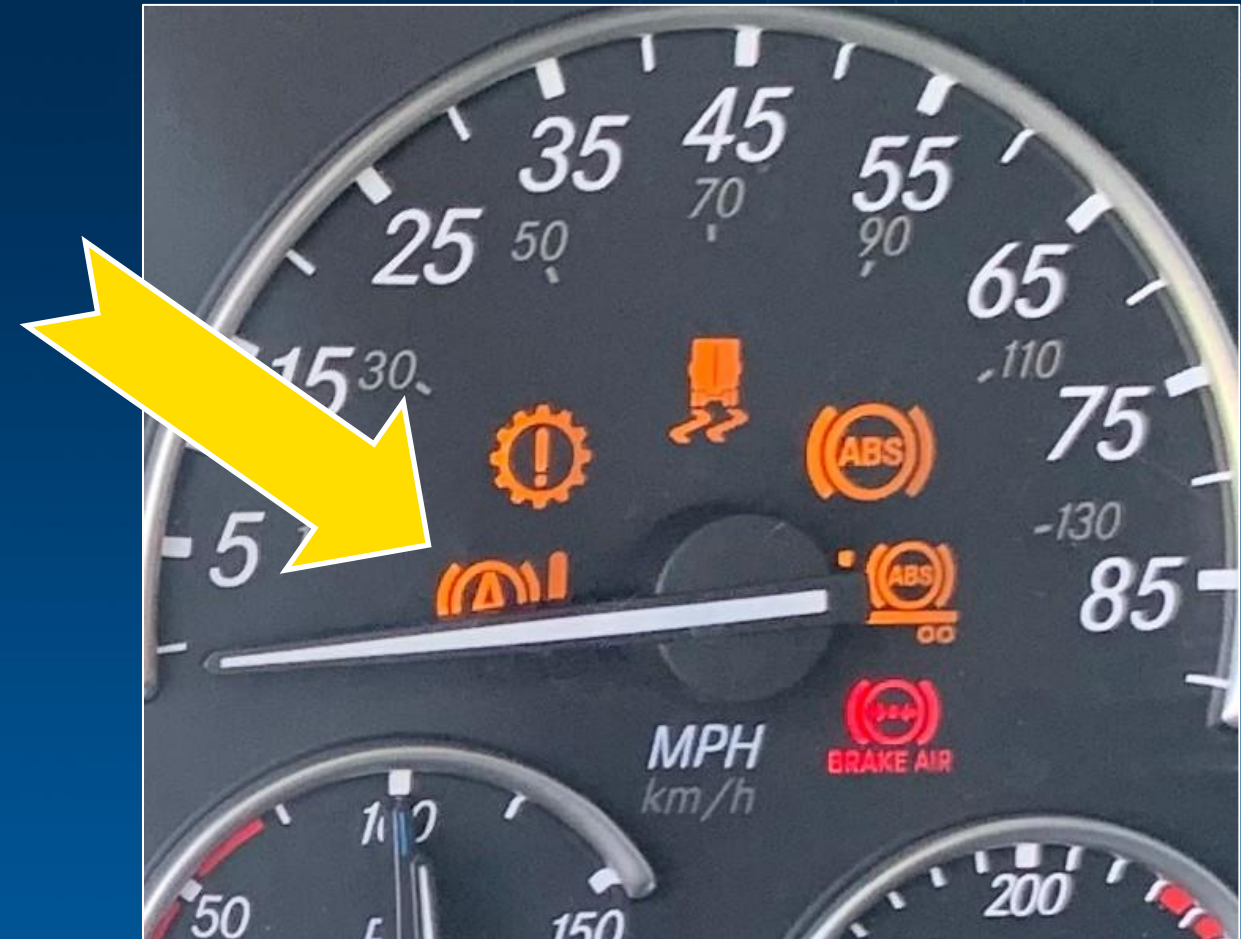
Driver Vehicle Inspection Reports from UPS Truck 1

- UPS Truck 1 – misaligned radar sensor
- Error code and warning since June 2019
 - Detected by Penske in July 2019
 - Noted several times on maintenance records
 - No Driver Vehicle Inspection Report (DVIR) entry by driver

- Penske
 - Places vehicle with Forward Collision Avoidance System defects out of service
 - Lessor receives notification email
 - Between May 2020 and December 2021, over 6,300 vehicles affected
- UPS
 - Changed driver training
 - Changed check ride form to account for advanced safety systems
