Multivehicle Crash Near Mt. Pleasant Township, Pennsylvania

Crash Summary

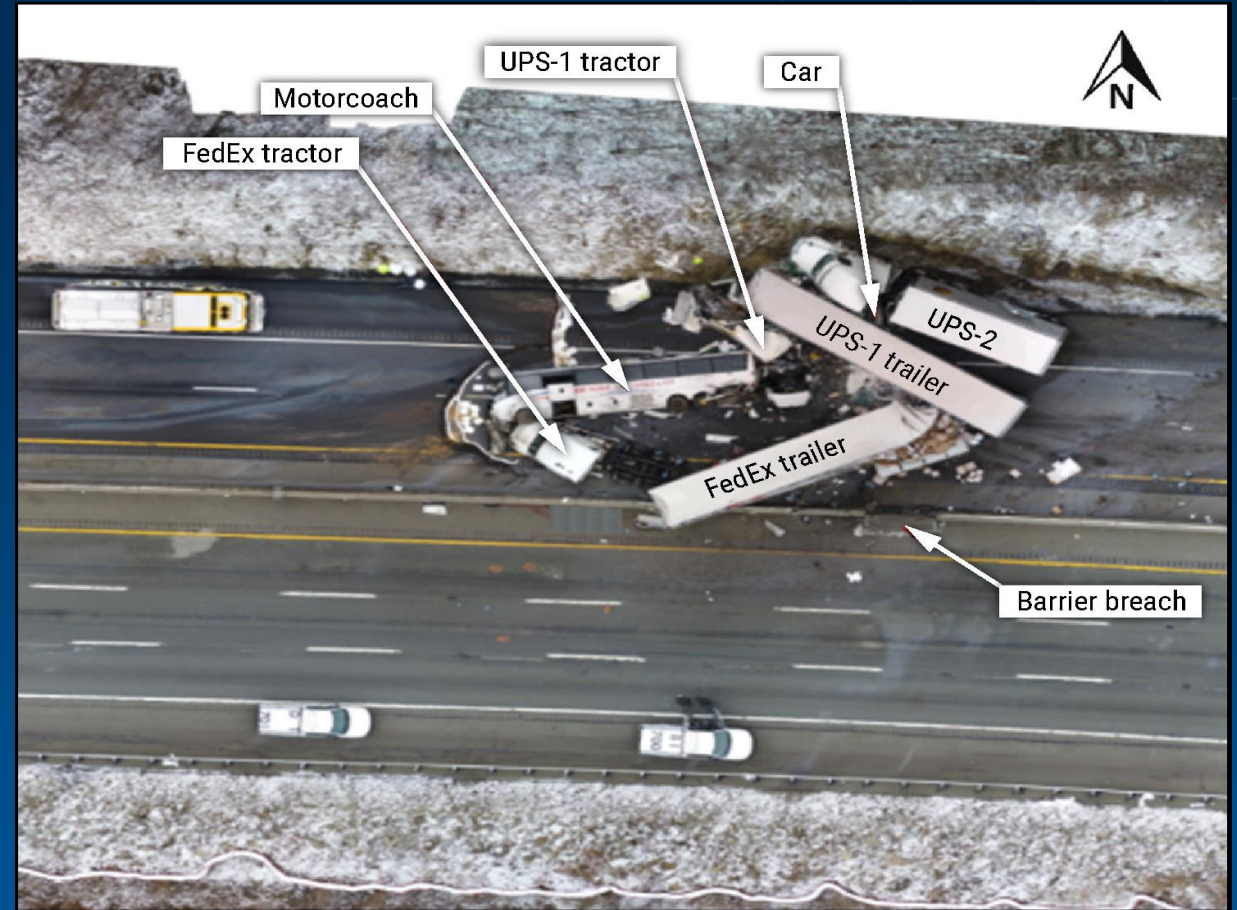
Crash Vehicles

- Final rest positions of vehicles
 - Motorcoach
 - FedEx tractor & trailer
 - UPS-1 tractor & trailer
 - Passenger car
 - UPS-2 tractor & trailer

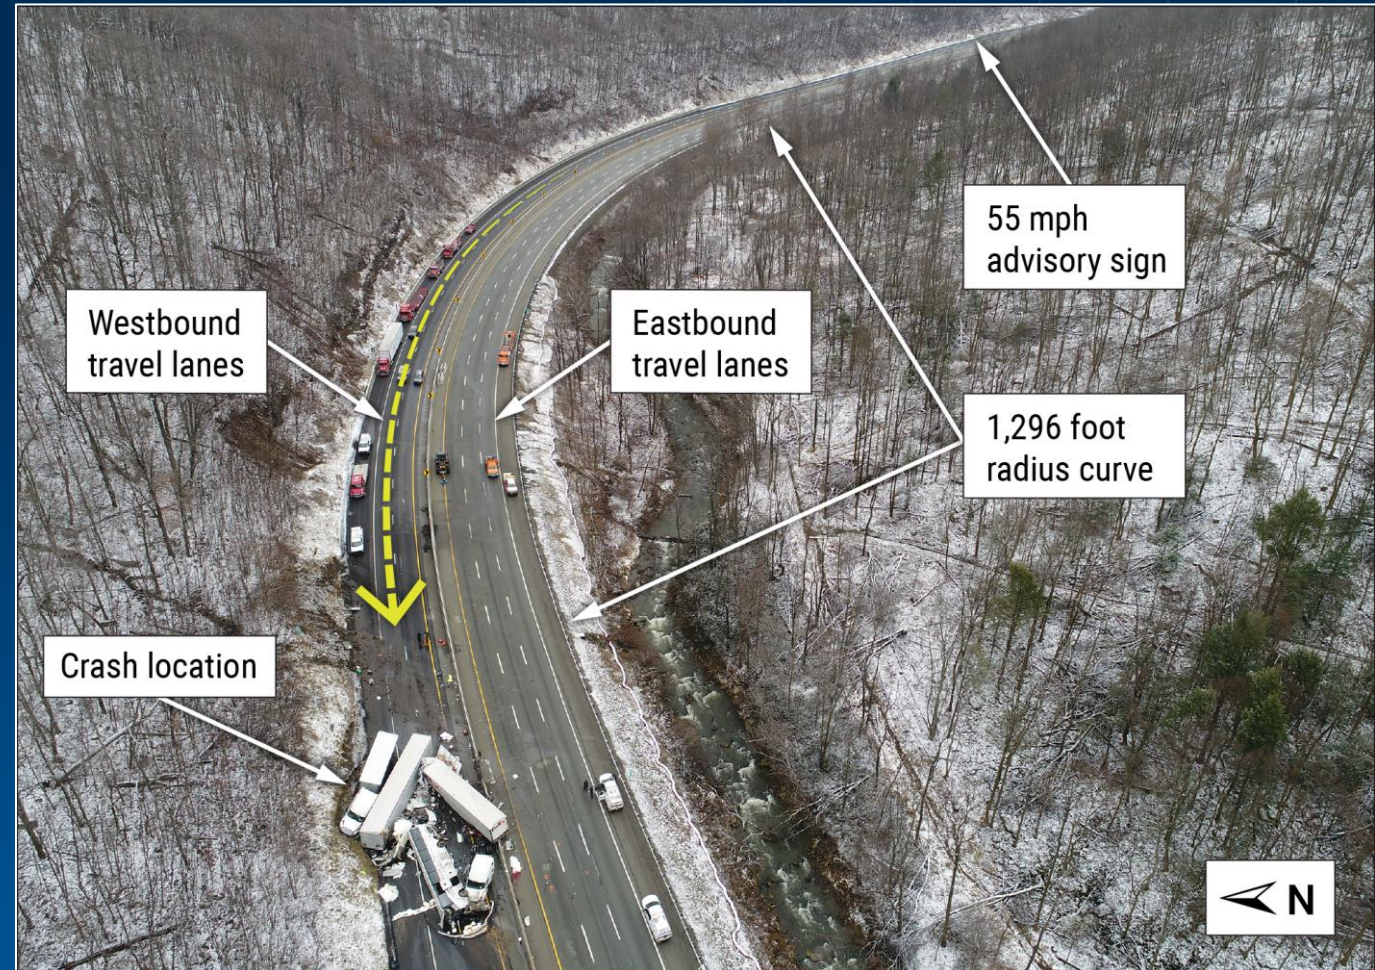
Crash Scene

- Vehicles at final rest
- Left-hand curve
- East and westbound lanes
- 55-mph warning sign

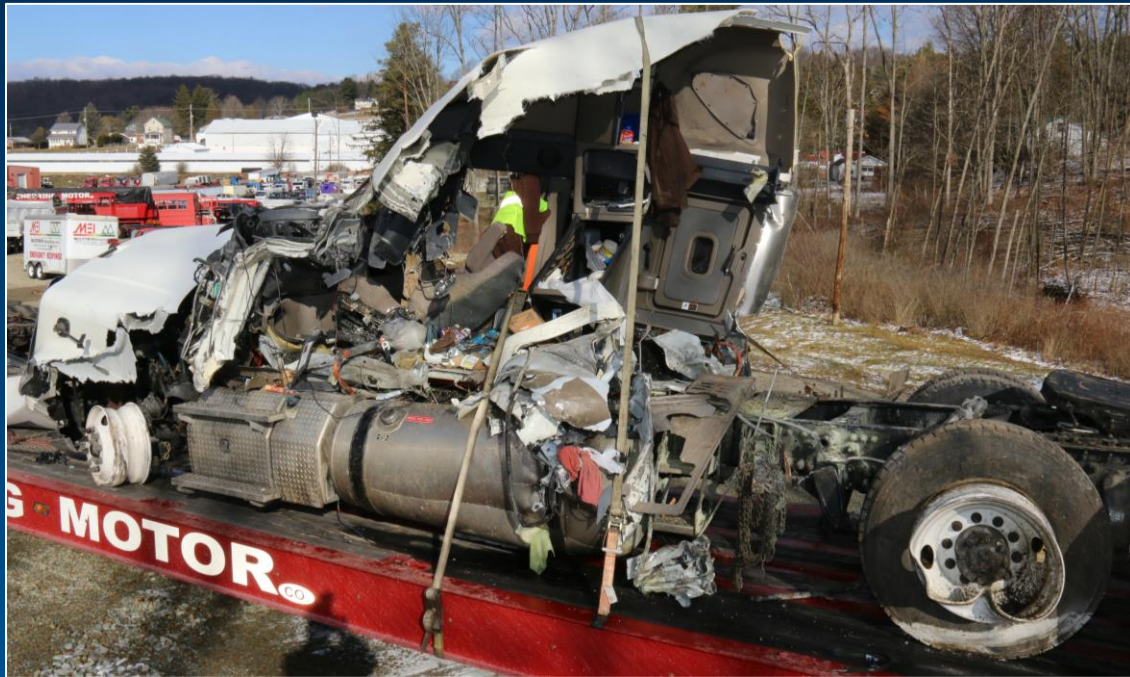
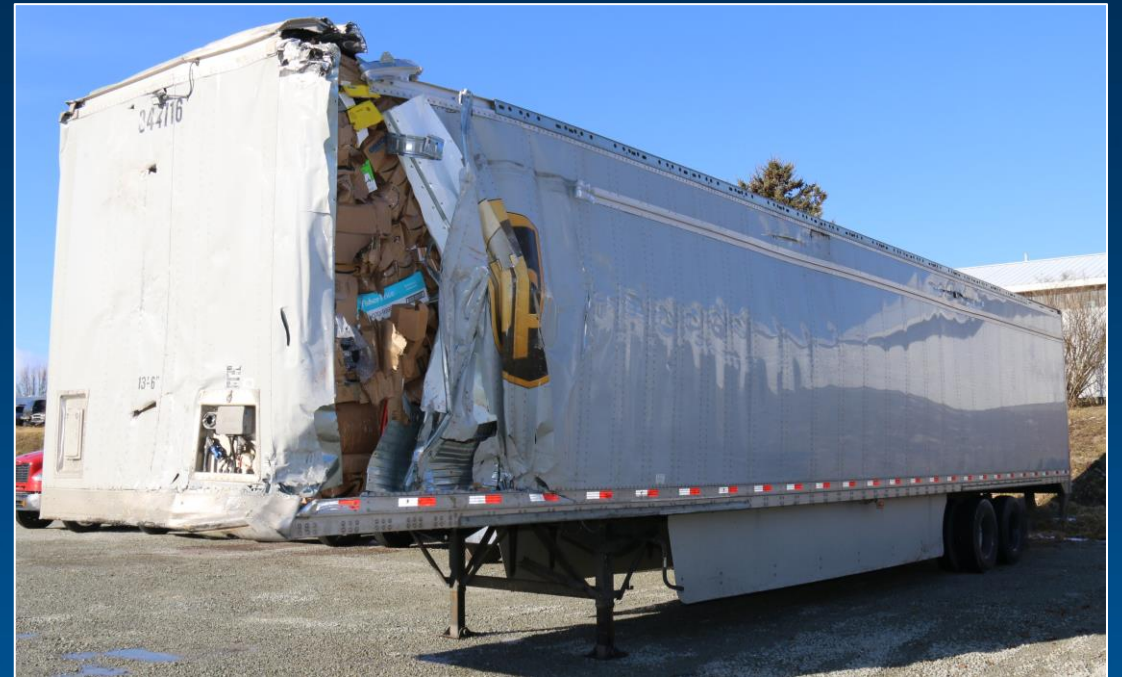
UPS-1 Combination Unit

- UPS Truck 1 – misaligned radar sensor
- Error code and warning since June 2019
 - Detected by Penske in July 2019
 - Noted several times on maintenance records
 - No Driver Vehicle Inspection Report (DVIR) entry by driver

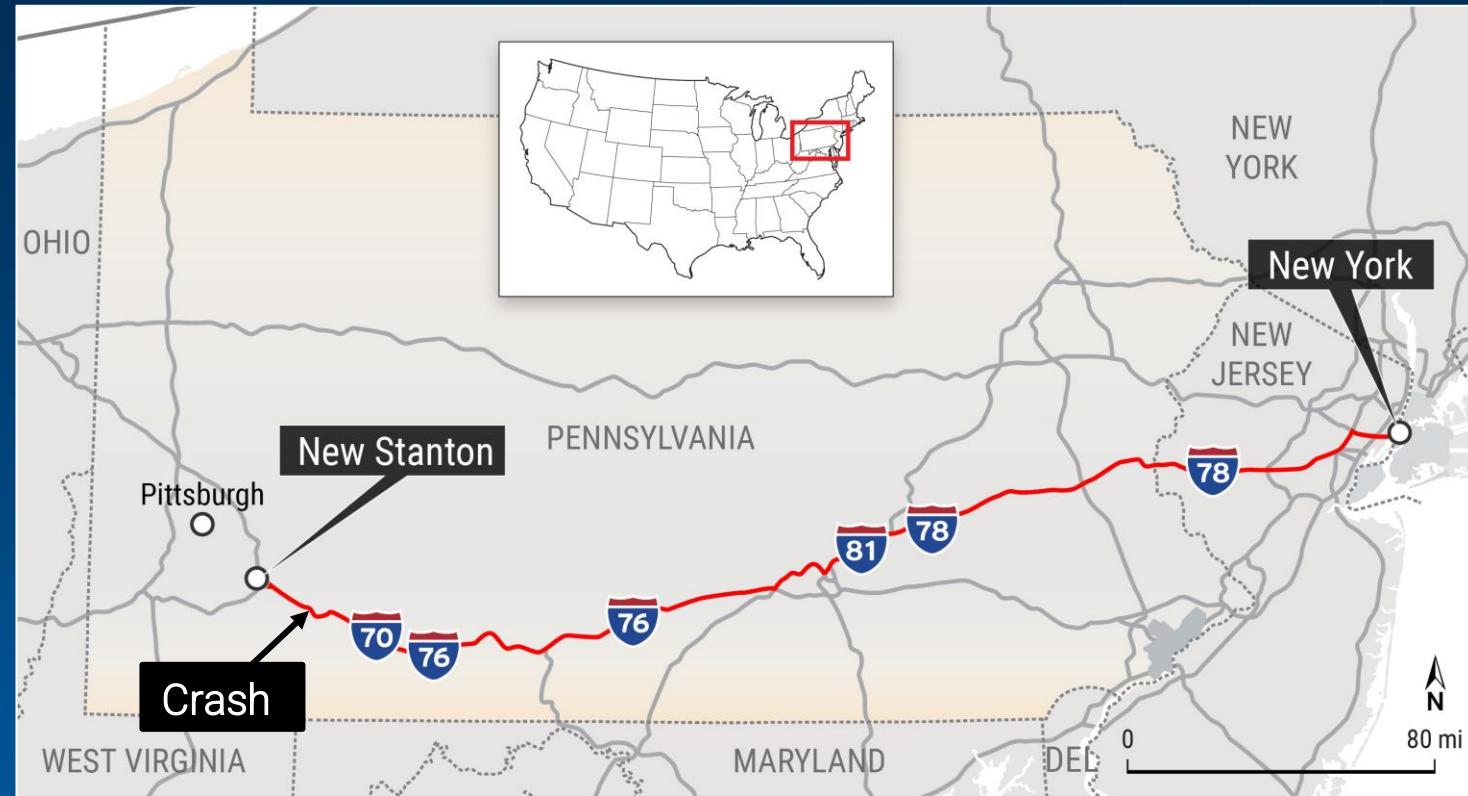
Motorcoach Crash Trip

- Departed NYC at 10:00 p.m.
- Scheduled arrival 4:15 a.m.
- 10 miles from destination
- Driving for 7 hours
- Unable to determine fatigue

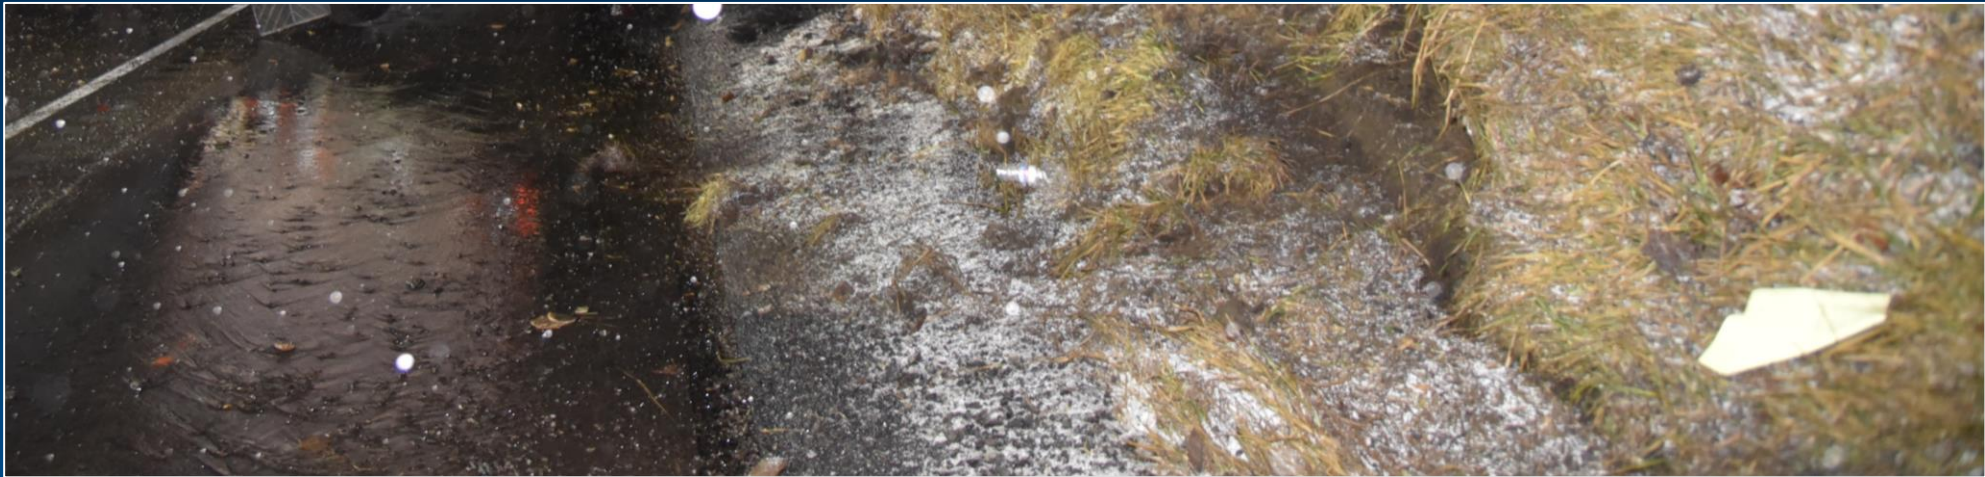
Environmental Conditions

Source: Pennsylvania State Police
